A CASE STUDY OF ENGINEERING ETHICS: LESSON LEARNED FROM BUILDING COLLAPSE DISASTER TOWARD MALAYSIAN ENGINEERS

M. F. Sulaima¹, H. S. Lew², C. Y. Lau³, Carolyn K. Y. Lim⁴, A. T. Azily⁵

Faculty of Electrical Engineering
Universiti Teknikal Malaysia Melaka,
Malacca, Malaysia

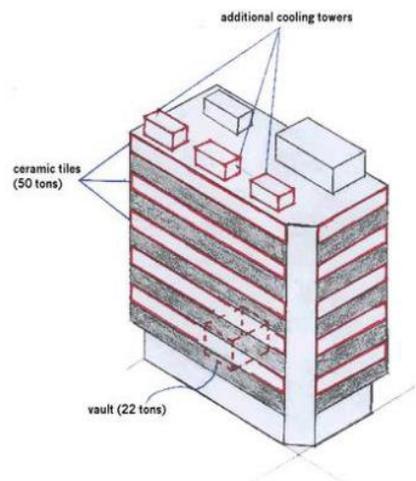
Fig. 1: Additional loads to the building [2].

Fig. 1 shows that heavy equipment, which were not stated in the original design plan, were found in the debris. Those equipment are the extra loads added by the owner during the building's 15 years of lifespan.

- i. In 1975, there was a vault with 22 tons placed in the bank on the ground floor.
- ii. In 1978, two additional cooling towers were added by the owner on the roof of the building.
- iii. In 1982, exterior layer on each floor were fixed with a heavy duty ceramic that carries a total of 50 tons due to architectural reasons.
- iv. In 1986, an extra cooling tower was added on the roof by the owner again.

Nevertheless, all these additional loads was already accounted under the live load category in the design plan. The engineer's calculations proved that the extra amount of weight does not contribute much to the collapse [4].

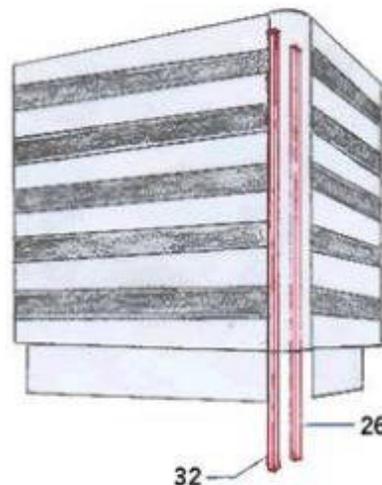
Fig. 2: Two columns that collapsed in the beginning [2].

Again, the engineers checked the blue prints and original design plan of the building. After calculation process, the root cause behind the collapse was finally discovered. Throughout this investigation, it was found that the dead load of the building was not accounted in the original design plan and it means that the building itself had been stressed to the allowable limit from the first day and the collapse cannot be avoided [4].

As a conclusion, the source of collapse was determined to be the fault of the engineers responsible for the structural integrity of the building as they overlooked the importance of dead load in the construction stage which caused the under-designed columns and foundation of the building's supporting elements to crack easily during the addition of the huge live loads. The tragedy of the Hotel New World building is a type of progressive collapse. Progressive collapse occurs when a structural failure in an area continuously spread to other area through connective structure causing an enormous destruction of a building. In this case, it is due to over stressed column that caused micro-cracks in the building and subsequently downfall.

The two major columns that were affecting the overall collapse of the Hotel New World are shown in Figure 2. Column 26 experienced micro-cracks initially due to the over stressed condition. The weakening of the support structure in column 26 caused the other load propagate to another column which was the column 32. As a consequence, column 32 also unable to support the additional weight hence experienced the micro-cracks. Thus, other columns in the other corners are eventually having the same problem due to the large live load and dead load which led the whole building to collapse [6]. Fig. 3 shows the before and after the Hotel New World collapsed.
