A CASE STUDY OF ENGINEERING ETHICS: LESSON LEARNED FROM BUILDING COLLAPSE DISASTER TOWARD MALAYSIAN ENGINEERS

M. F. Sulaima¹, H. S. Lew², C. Y. Lau³, Carolyn K. Y. Lim⁴, A. T. Azily⁵

Faculty of Electrical Engineering
Universiti Teknikal Malaysia Melaka,
Malacca, Malaysia

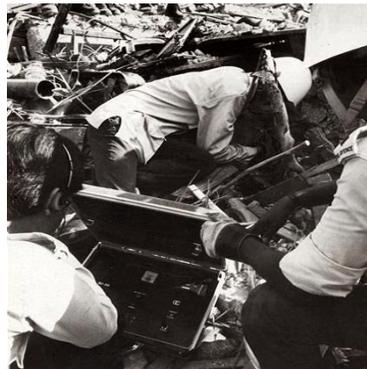
Fig. 4: Rescue operation [7].

After five day rescue operation, 17 people were rescued but 33 people were killed. Fig. 4 shows the rescue operation conducted at the day of collapse.
